## ENGINEER'S CONSTRUCTION OBSERVATION REPORT

Project: Queen's Gap	Project Number: 2013-002	
Contractor: Site Development Corporation	Contact at Site: Tim Fox, Curt Dalziel	
Date: 2/8/2016	Time of Arrival 9:00 am	Weather Conditions: Wet soils, non- workable.
Notice to Proceed:	Substantial Completion Date:	
Previous Rain Days:	Previous Substantial Completion Date:	
Rain Days Since Last Report:	Total Rain Days:	Current Substantial Completion Date:

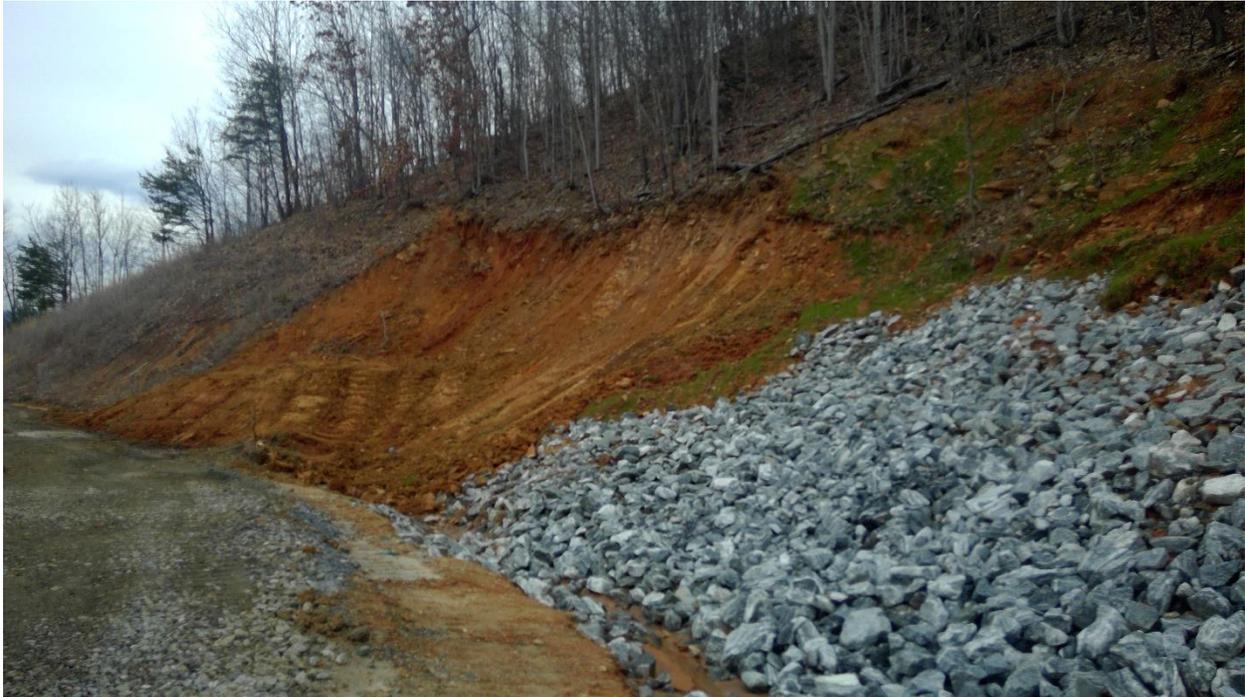
The remainder of the project was inspected for NCG010000 monitoring. Two new slopes failures occurred in the vicinity of the current slope repair areas. Erosion control maintenance is required project wide including but not limited to: ditch line rock check dams, wattles and matting materials, sediment fence, inlet protection, road bed maintenance, slope repairs and re-vegetation.

**Slope failure – Project 3 area.**

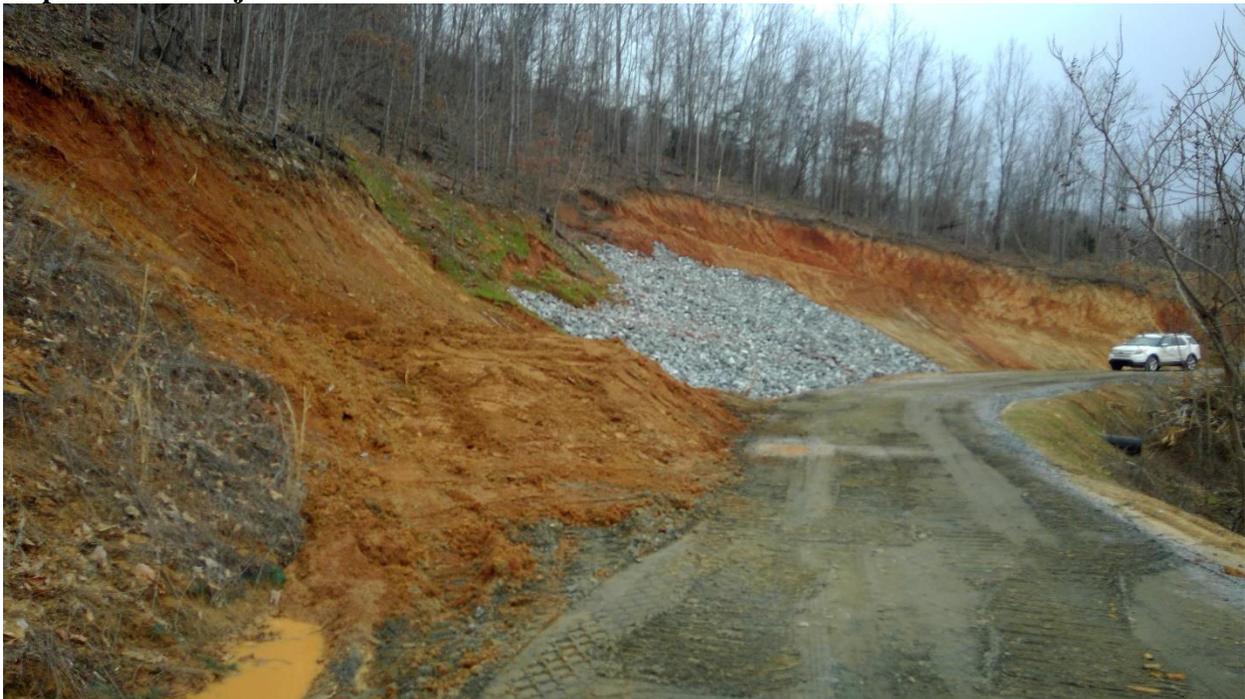
**Slope failure – Project 3 area, opposite view.**

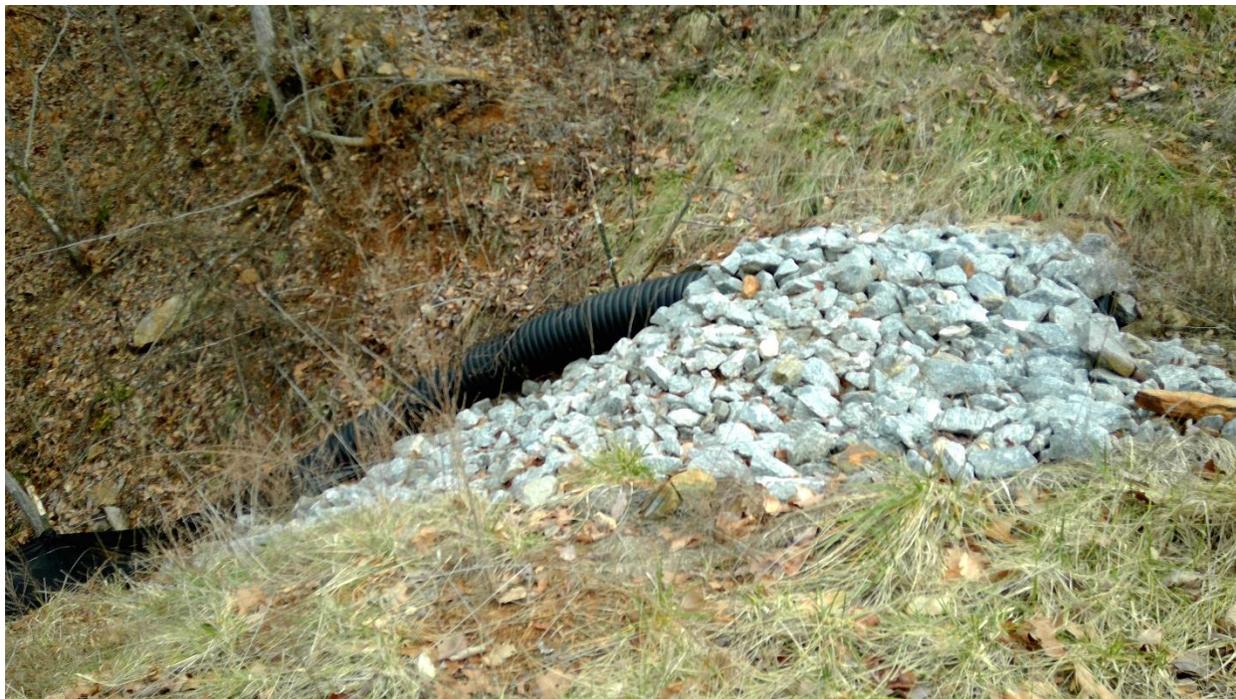
**Pipe slope drain to be removed. Request made by (DWR).**

Three (3) additional areas were inspected from other Notice of Violations under (DWR) jurisdiction. Mr. Fox requested removal of a slope drain entering the stream at the box culvert location. Restoration and site cleanup was requested at the intersection of the main roadway and soil side road. The culvert pipe in the soil road is obstructed with soil material and the stream has re-routed to a roadside ditch line. Mr. Fox asked for the stream to be restored to original route and the area stabilized. No work to be performed in the wetland area.

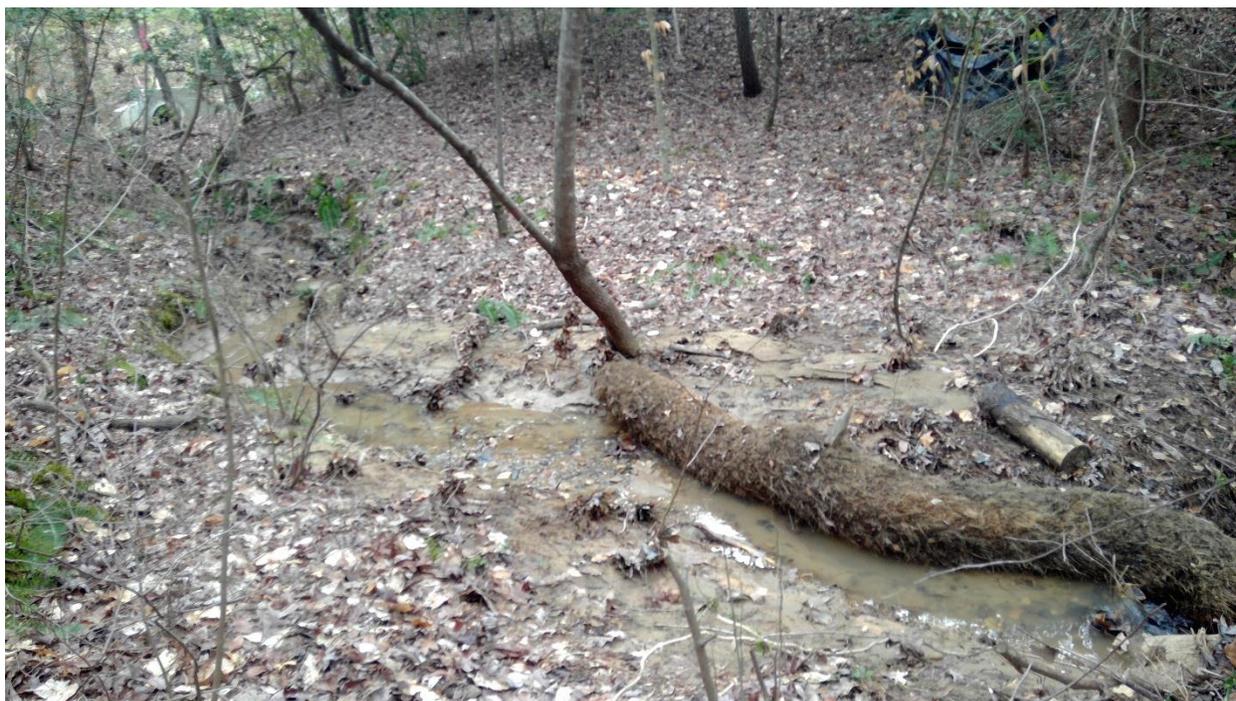
Met on-site to discuss problems associated with the rainfall event of last week – (5") reported at the site. Division of Water Quality reported a complaint from downstream property Owner regarding sediment deposition from the project site (area of stream restoration recently completed by Curt Dalziel).

**Sediment deposition near beginning of the stream cleanup area. Wattle washed downstream.**

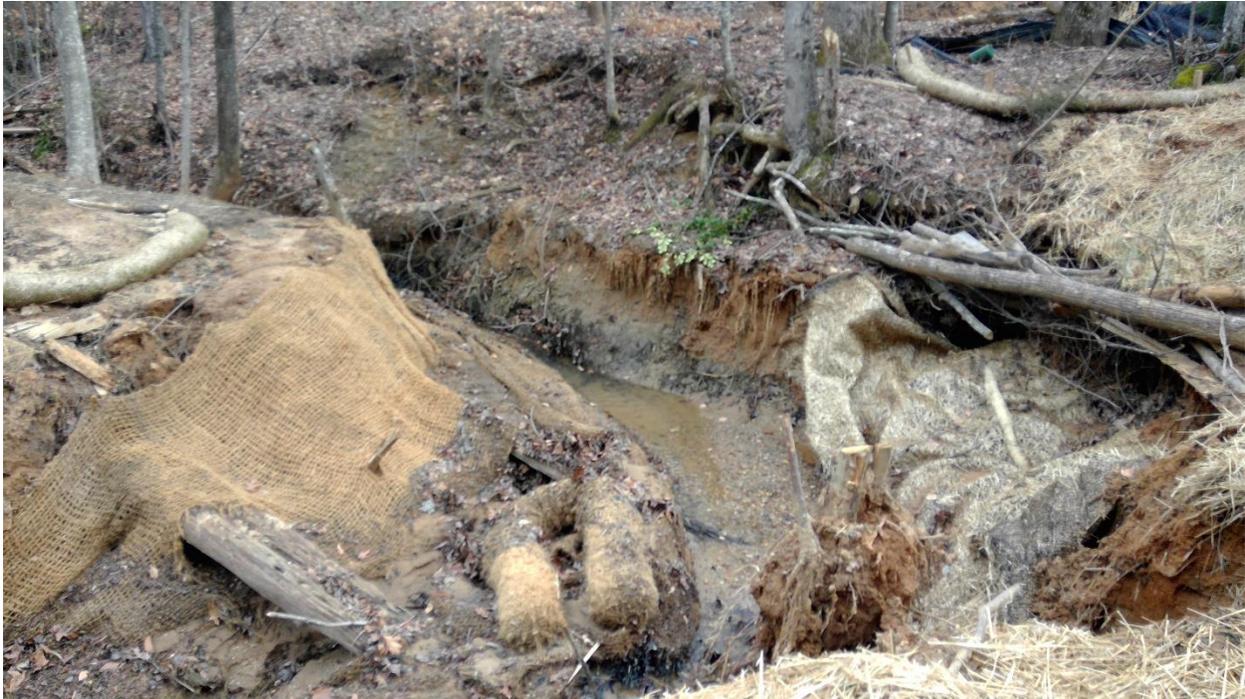
The rainfall event caused serious erosion control problems project wide. The stream embankments were significantly damaged with coir wattles, excelsior matting and soil embankment washed out. Mr. Fox reported that the project remains under Notice of Violation and maintenance is required to stabilize and re-vegetate the stream restoration area. He suggested consideration of live staking of the lower 4-5' of stream bank in areas where stream velocities are eroding embankments.

**Embankment washed out in bend of stream.**

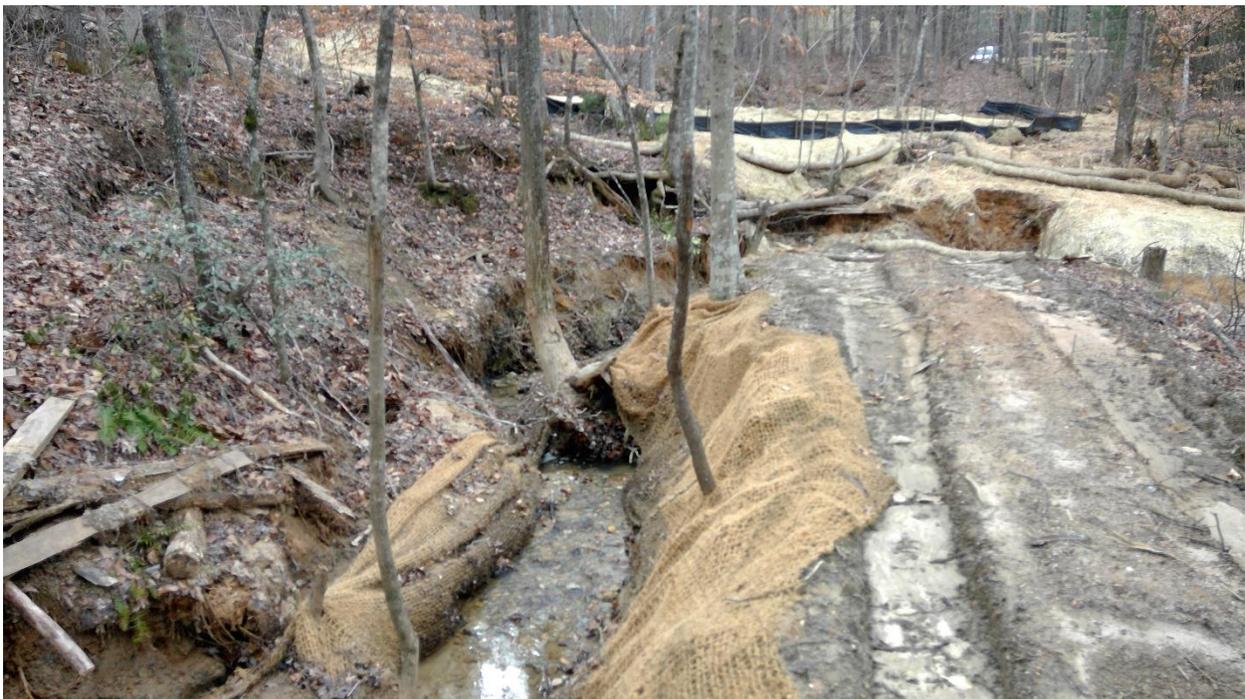
**Embankment washouts in the restoration project area.**

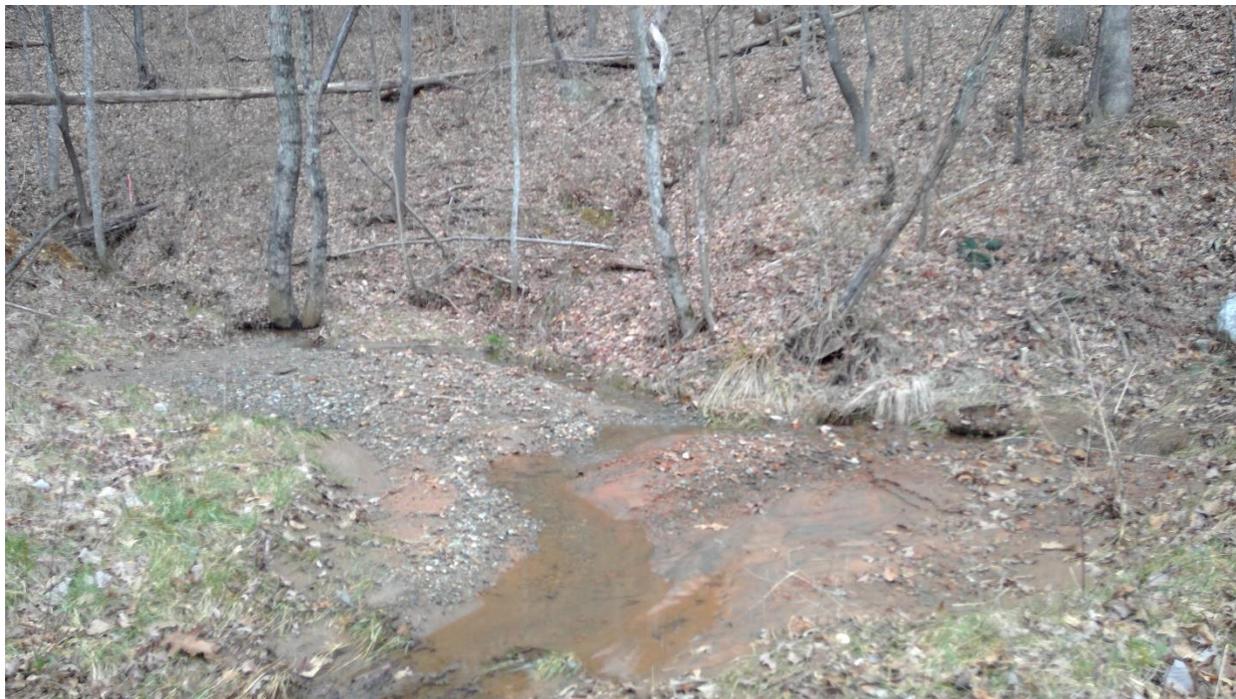
**Sediment deposition, obstructed culvert pipe and stream diversion at soil road and main roadway.**

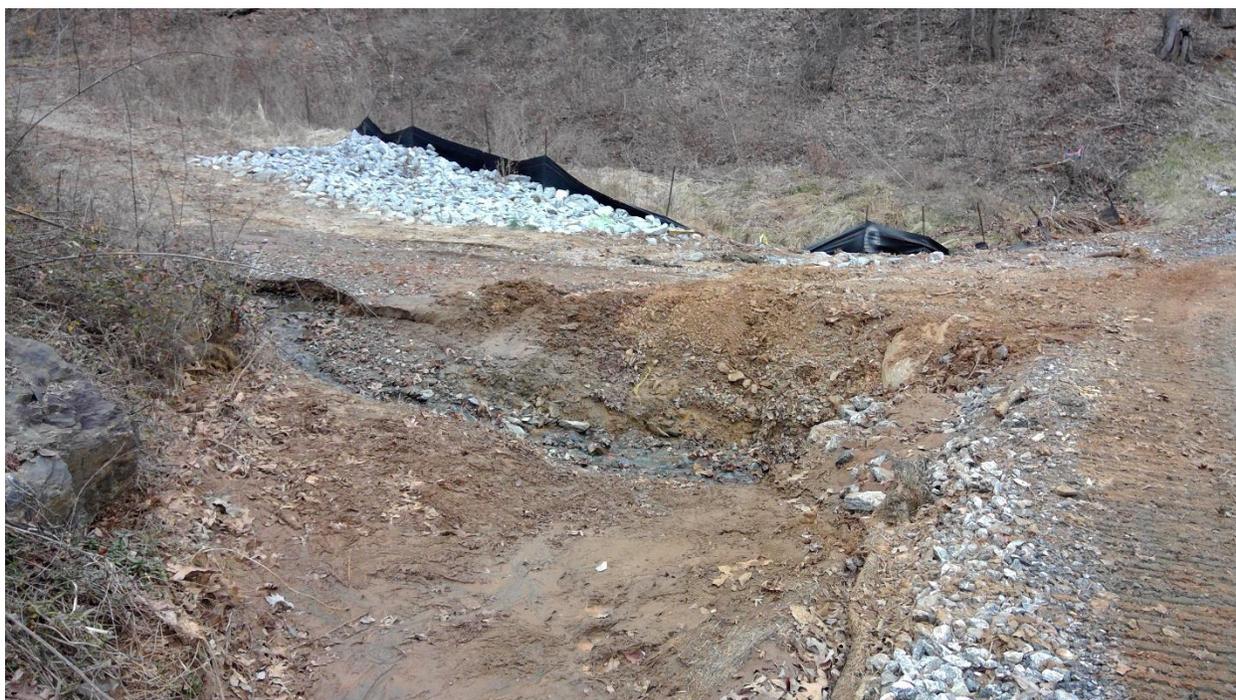
**Erosion and ditch line washout at soil road – stream diverted to this area.**

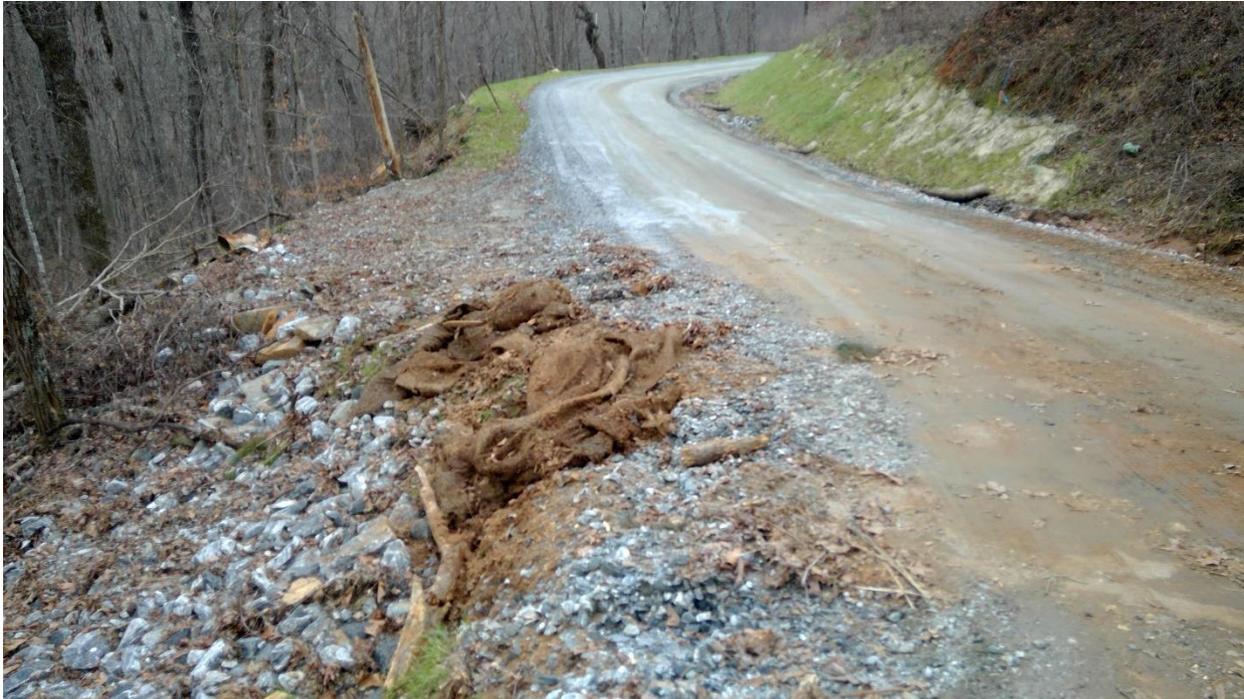
**Excelsior ditch line protection washed out of the ditch line, deposited across the road.**

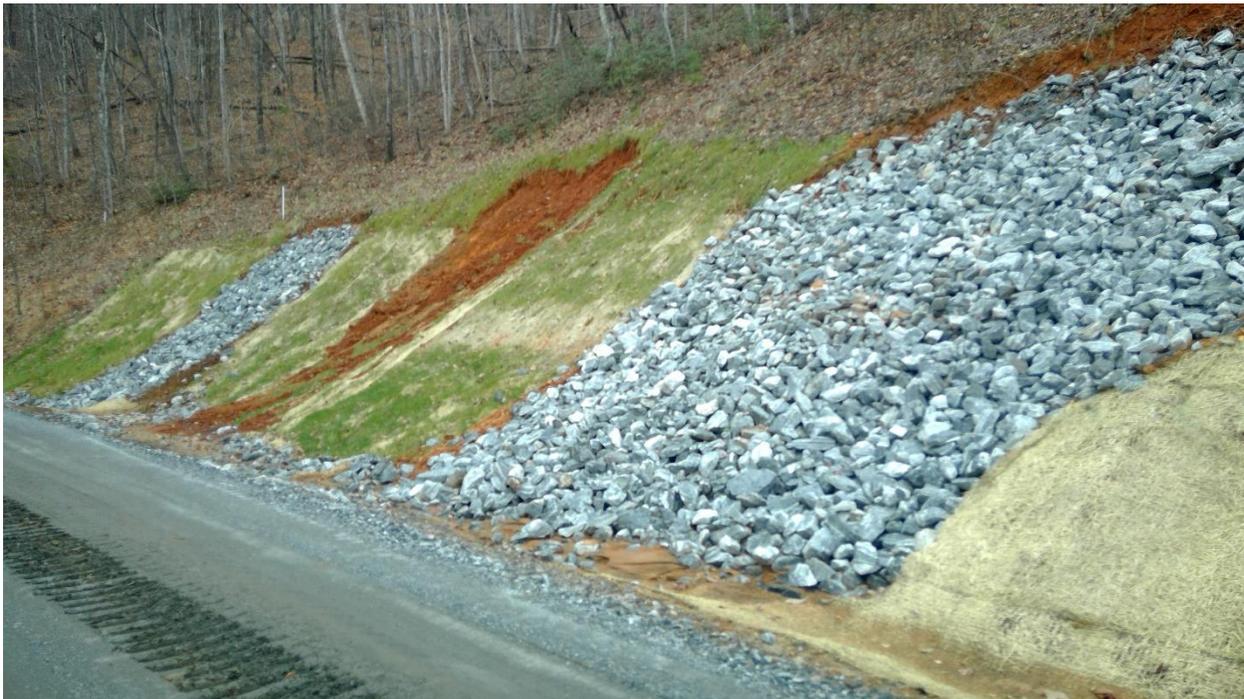
**Slopes failure (mid-section of photo) same area as Project 3 repairs.**
