## ENGINEER'S CONSTRUCTION OBSERVATION REPORT

Project: Queen's Gap	Project Number: 2013-002	
Contractor: Site Development Corporation	Contact at Site: Paul	
Date: 01-06-2016	Time of Arrival 10:00 am	Weather Conditions: Wet soils, workable.
Notice to Proceed:	Substantial Completion Date:	
Previous Rain Days:	Previous Substantial Completion Date:	
Rain Days Since Last Report:	Total Rain Days:	Current Substantial Completion Date:

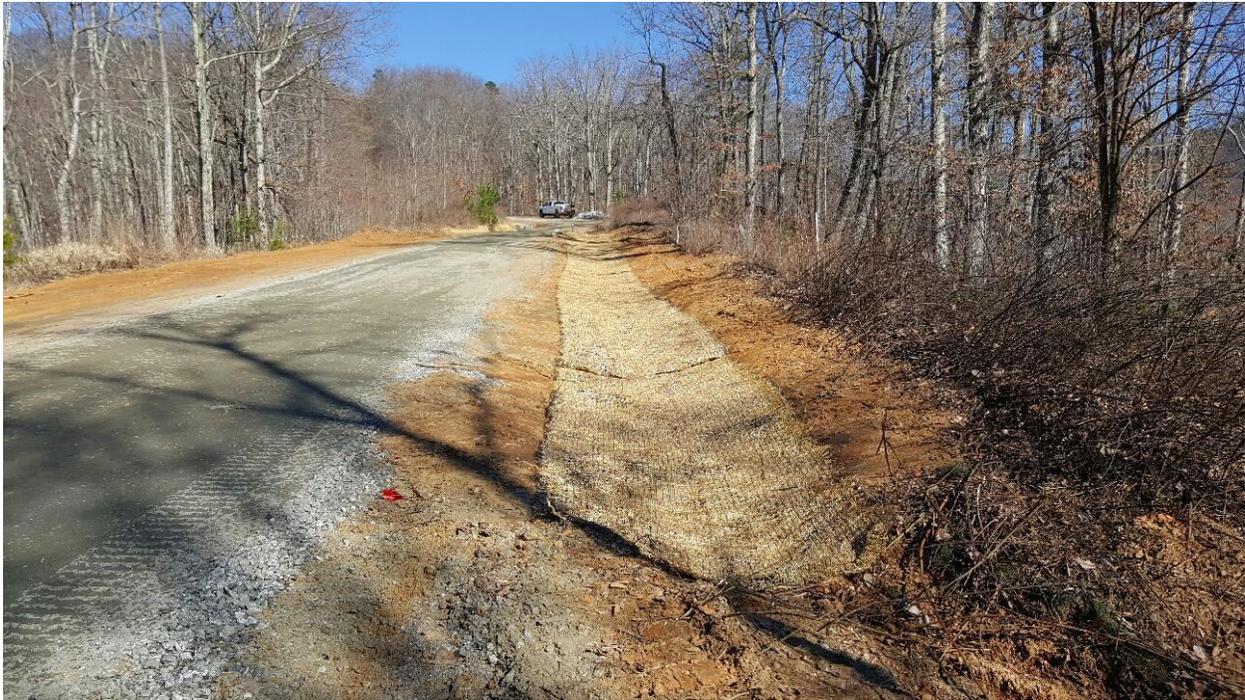
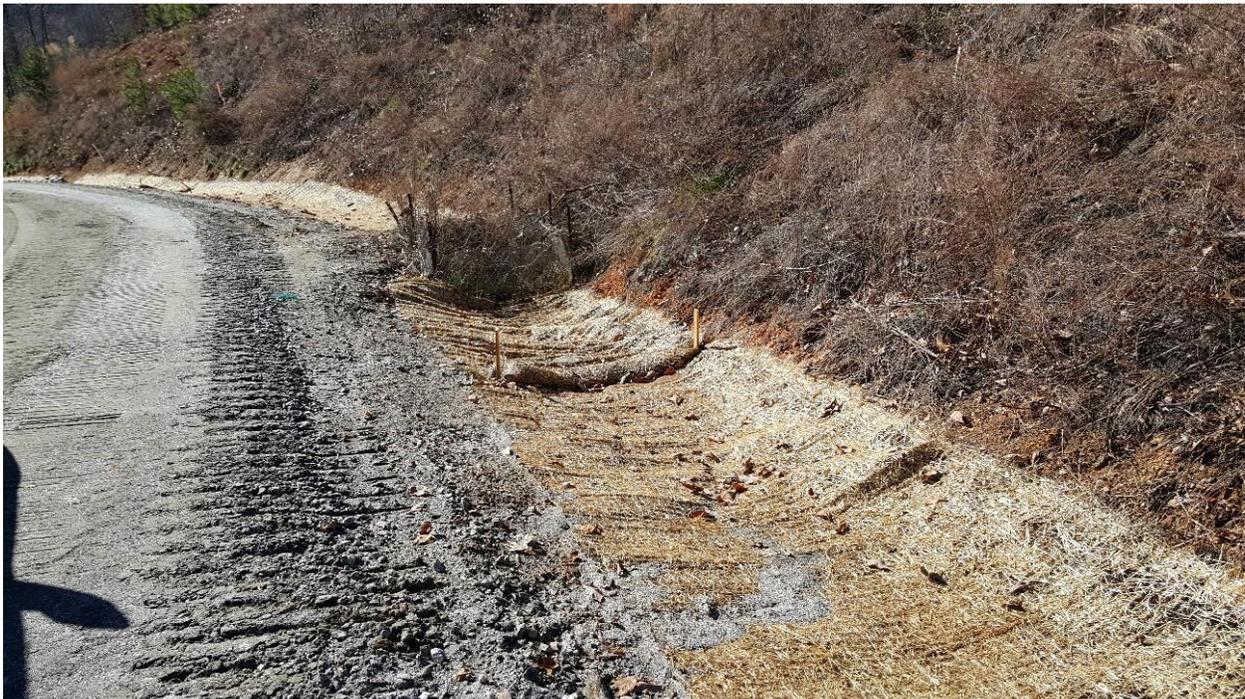
**Project 3 – The Contractor is working on the slope repairs in Project 3 area. Rip Rap armorment is being placed on the slope areas that previously failed during the heavy rainfall events of December 2015.**

**Project 5 – Work has been performed on the roadway and channel construction for the main roadbed. NAG SC 250 rolled erosion control product is being installed with rock check dams at various intervals as needed.**

- **Remove sediment accumulations in all areas such as drainage channels, check dams, wattles and areas where sediment has migrated from rainfall events.**
- **Repair and/or replace rock check dams that have accumulated sediment to capacity.**
- **Restore all catch basins to working order. Repair inlet protection and restore all to working condition. Prevent sediment from entering catch basins all areas.**
- **Re-vegetate all disturbed areas by seeding, mulching and or matting.**
