ENGINEER'S CONSTRUCTION OBSERVATION REPORT

Project: Queen's Gap	Project Number: 2013-002	
Contractor: Site Development Corporation	Contact at Site: Jim Worley	
Date: 03/03/2016	Time of Arrival	Weather Conditions: Wet soils, workable.
Notice to Proceed:	Substantial Completion Date:	
Previous Rain Days:	Previous Substantial Completion Date:	
Rain Days Since Last Report:	Total Rain Days:	Current Substantial Completion Date:

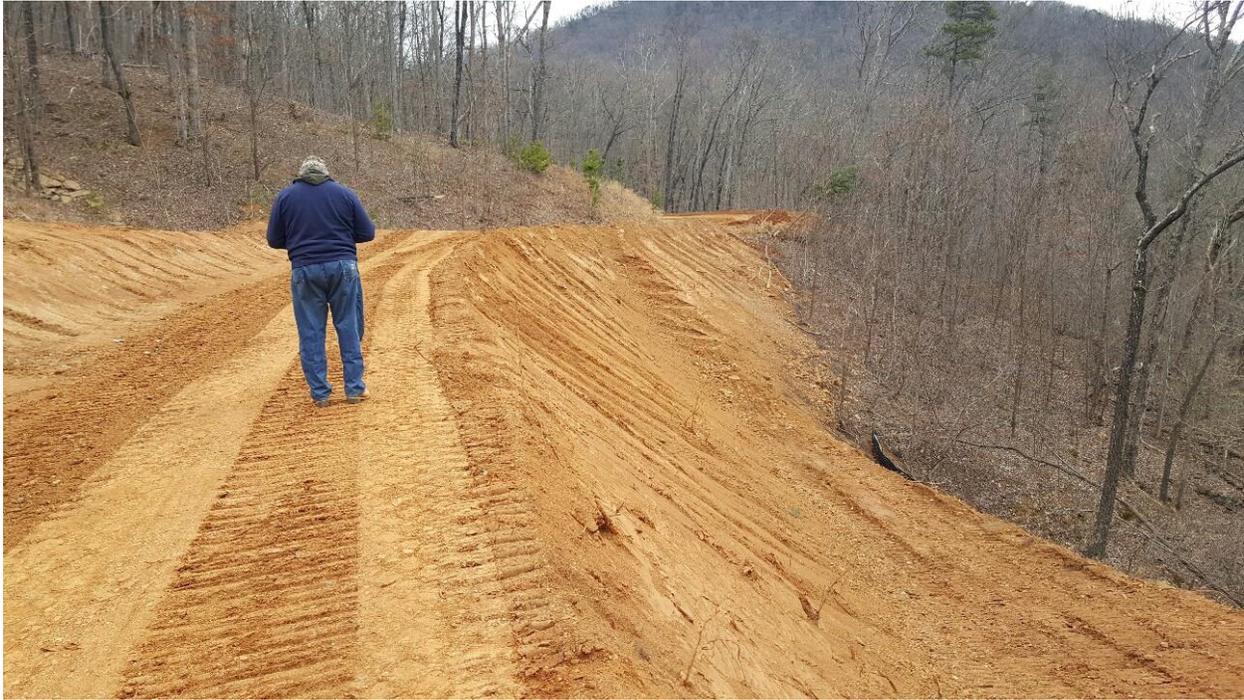
Slope construction to be extended outward to the right of the photo with storm drainage pipe installation and extended fill down slope. Additional clearing required and the slope lengthened required per plans. **Construction surveying / staking for the proposed work is required in these areas.**

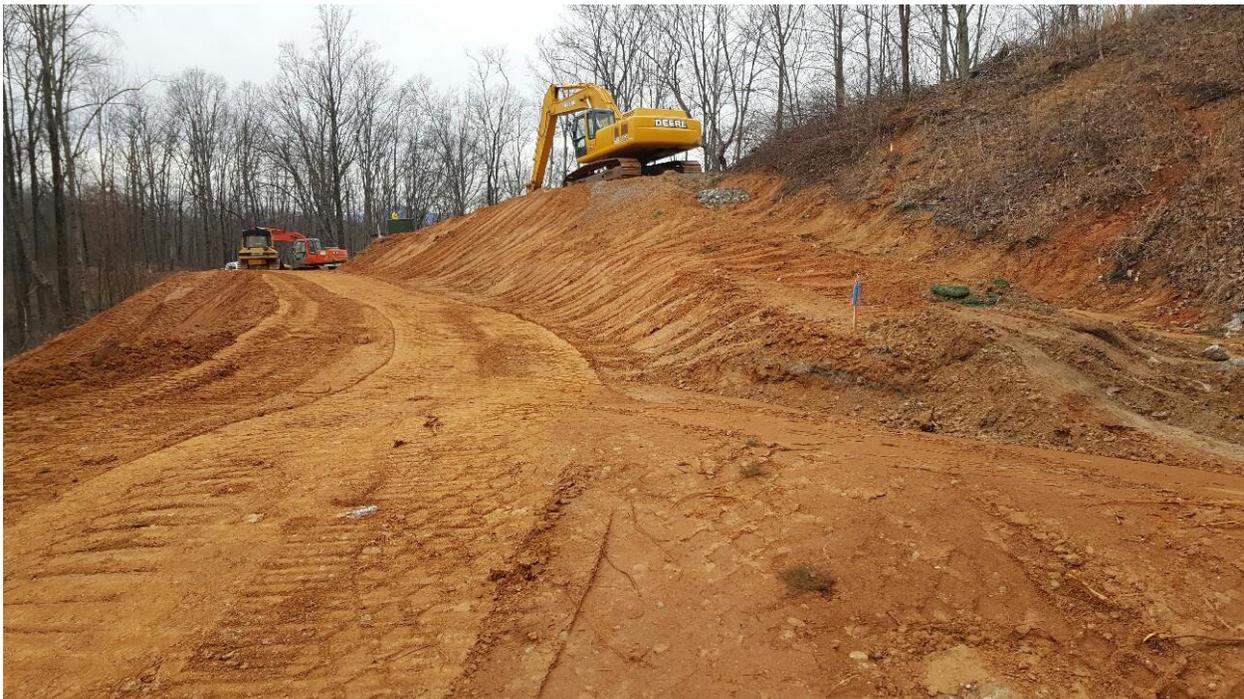
Drainage improvement re-construction discussed with the Contractor at intersection of Eamon Drive and Devon Ridge Road. Changes to the ditch line on the right to be considered. **Additional erosion control sediment fence is required below slopes in these areas.**

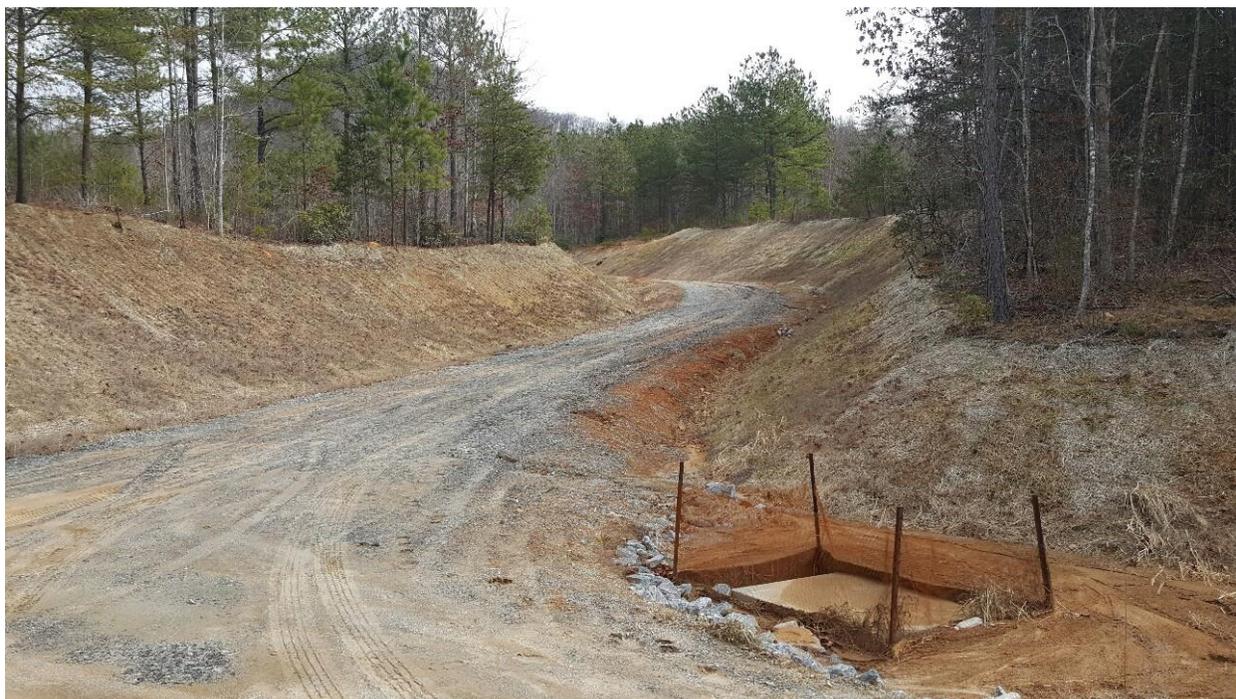
Area in Project 2 to be repaired by Dalziel Enterprises. Repairs required by NCDEQ.

Project 2 - Stabilization to be performed at the location of the main roadway and short cul-de-sac in Project 2 area by Dalziel Enterprises. Sediment removal at Inlet structures, ditch stabilization and re-vegetation of areas not previously stabilized to be performed. The work is associated with the latest storm damage and heavy rainfall. ***Scheduled by Dalziel.***

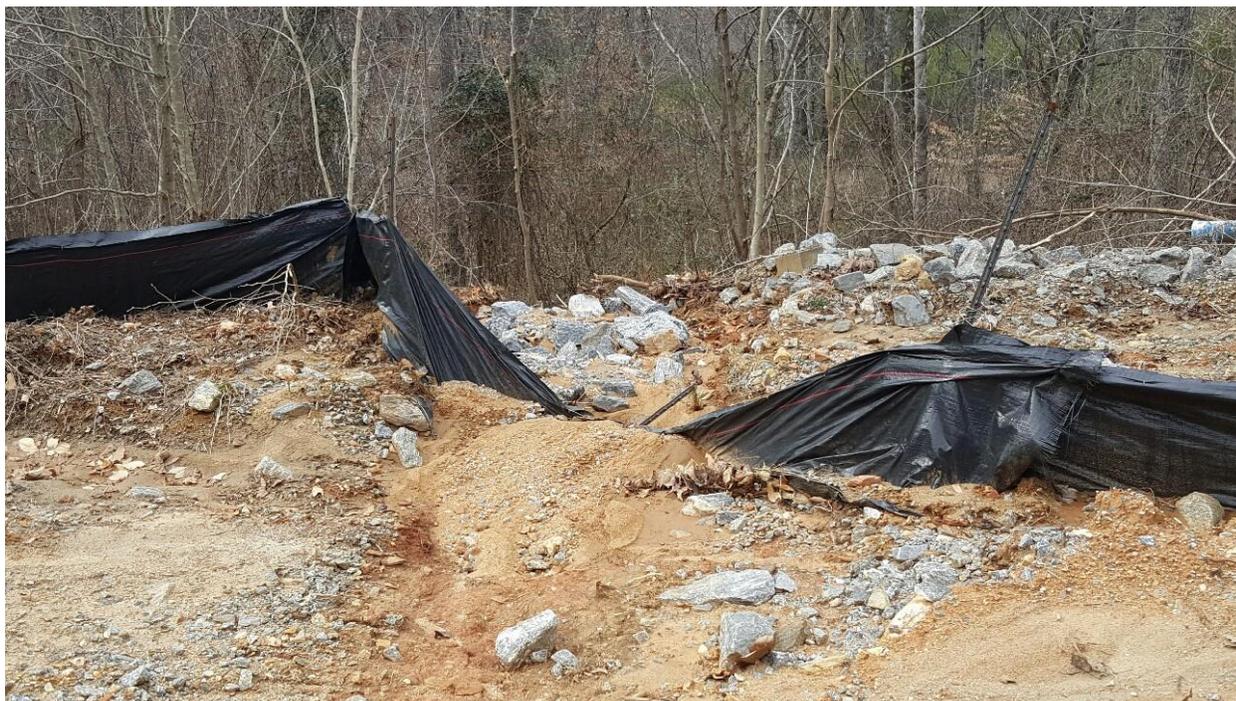
Sediment fence repairs to be corrected by Site Development Corp. Repair all damaged sediment fence project wide in areas that are not fully stabilized.

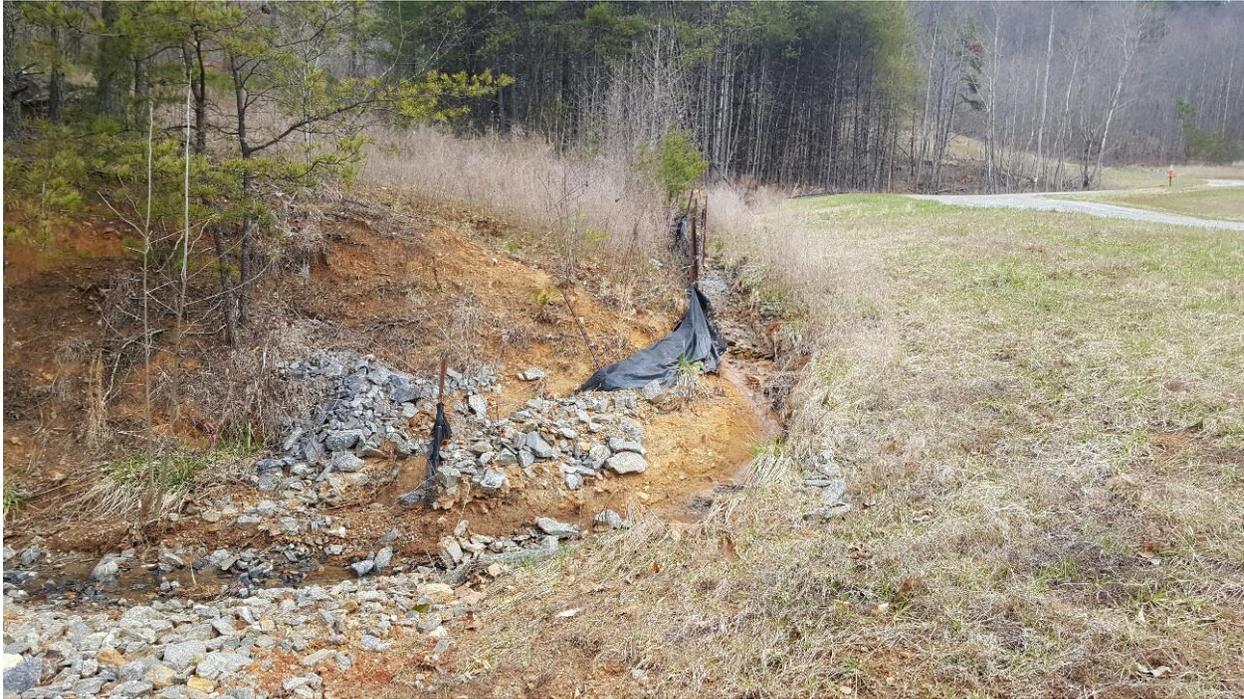
Remove damaged sediment fence and re-vegetate the disturbed areas by seeding and mulching.

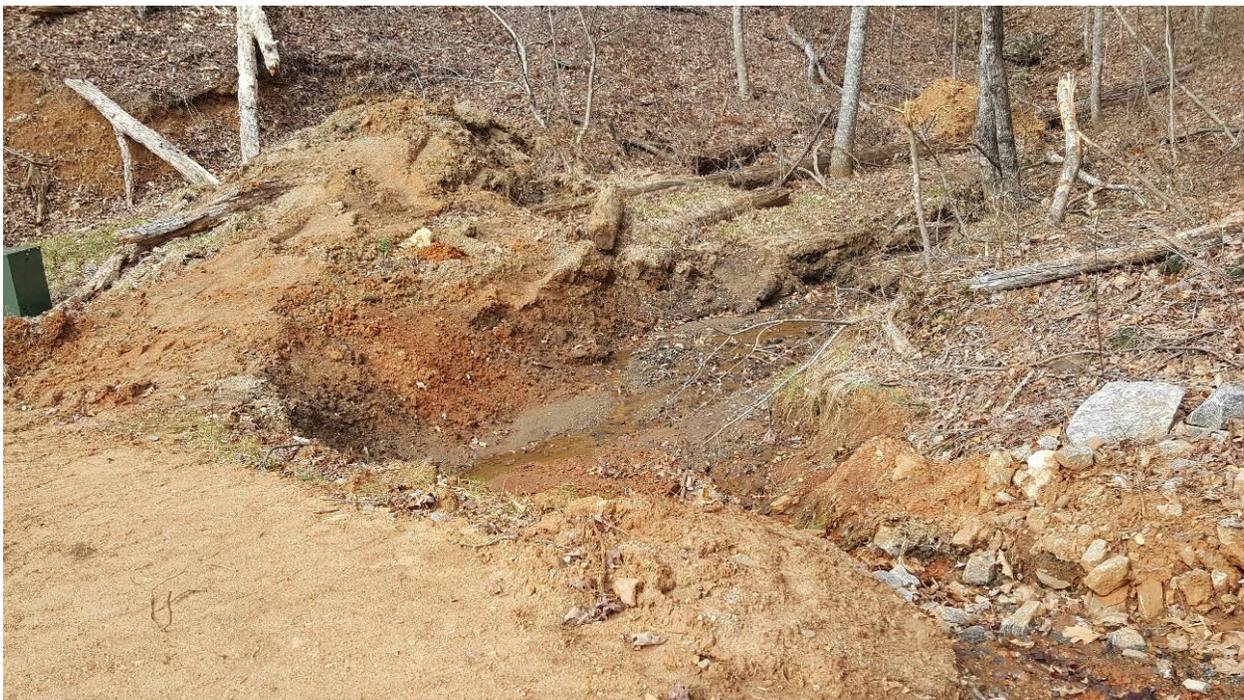
Finalize the cleanup work required by NCDWR and restore the area by seeding and mulching.

- Removal of a slope drain entering the stream at the box culvert location. Restoration and site cleanup was requested at the intersection of the main roadway and soil side road. The culvert pipe in the soil road was obstructed with soil material and the stream has re-routed to a roadside ditch line. Mr. Fox (DWR) asked for the stream to be restored to original route and the area stabilized. No work to be performed in the wetland area. ***Work in progress as of 02-17-2016, not complete as of this report.***

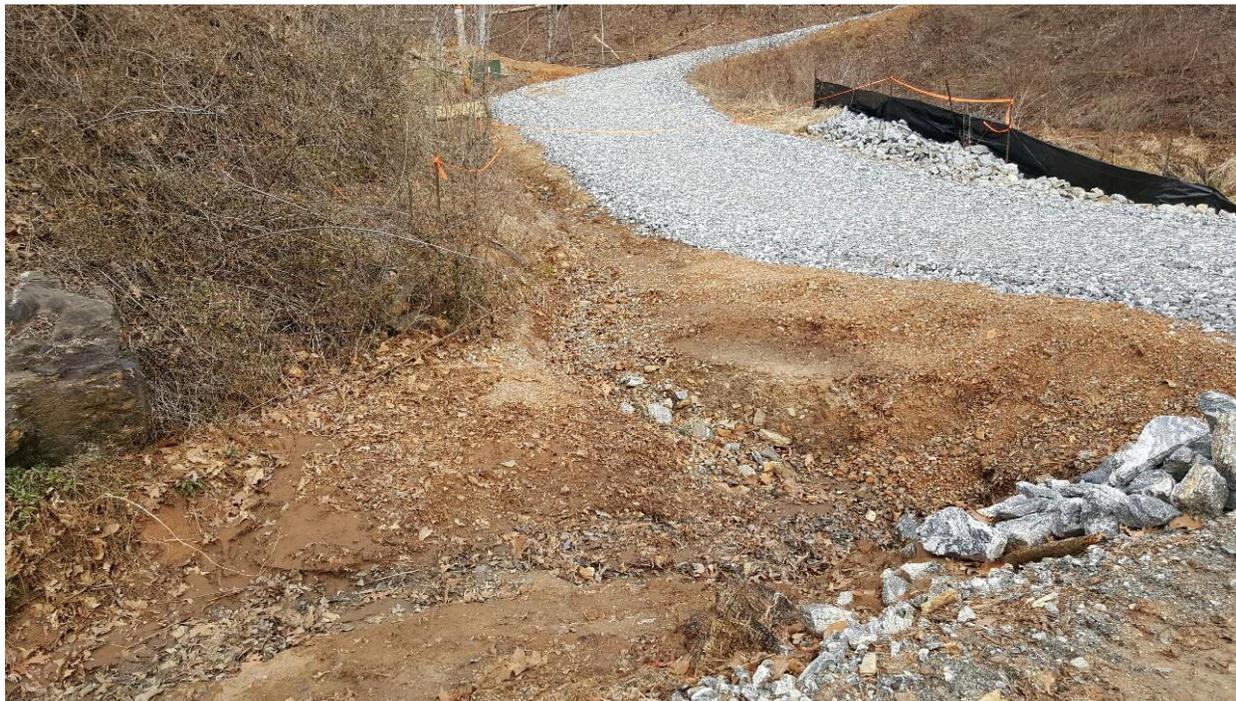
Stabilize the areas by seeding and mulching. Stabilize the ditch line by seeding and matting.

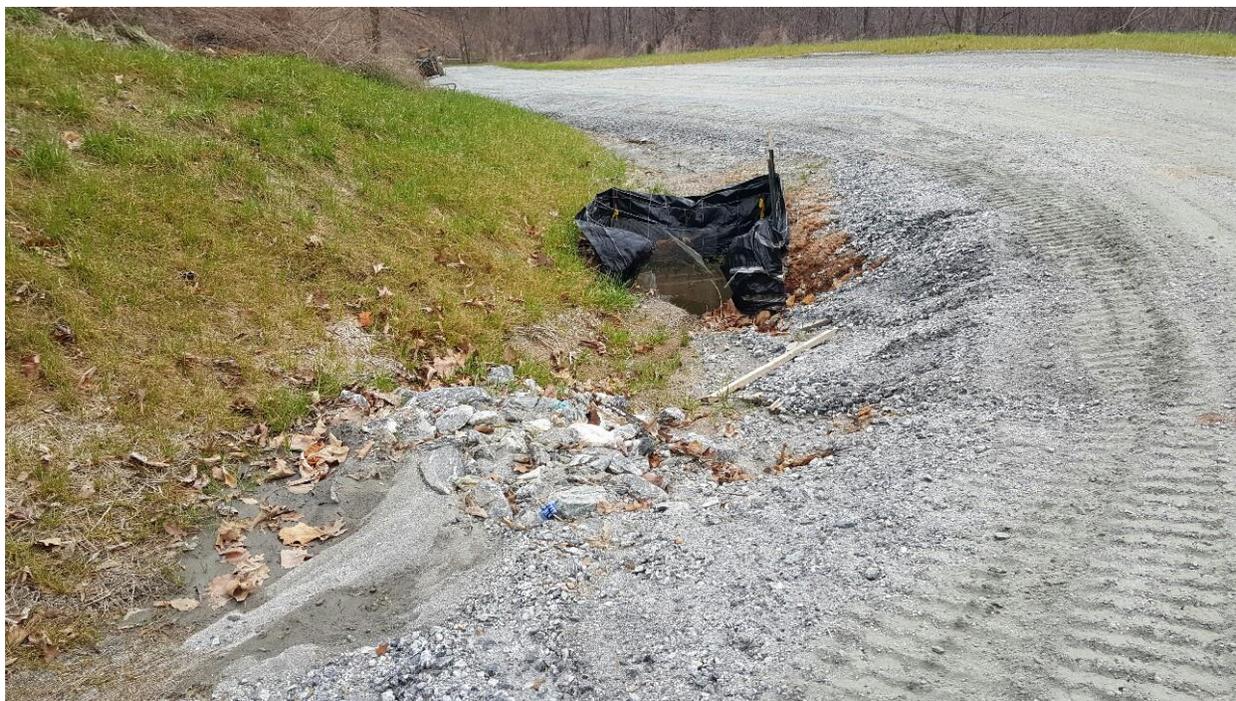
Repair damage drop inlet protection devices project wide. Repair rock check dams and ditch line wattles project wide.
